NASHVILLE FAIRGROUNDS SPEEDWAY

Upgrade Assessment

Prepared by Driven International

L150-DRVN-00-GEN-RP-00-0-01-P02

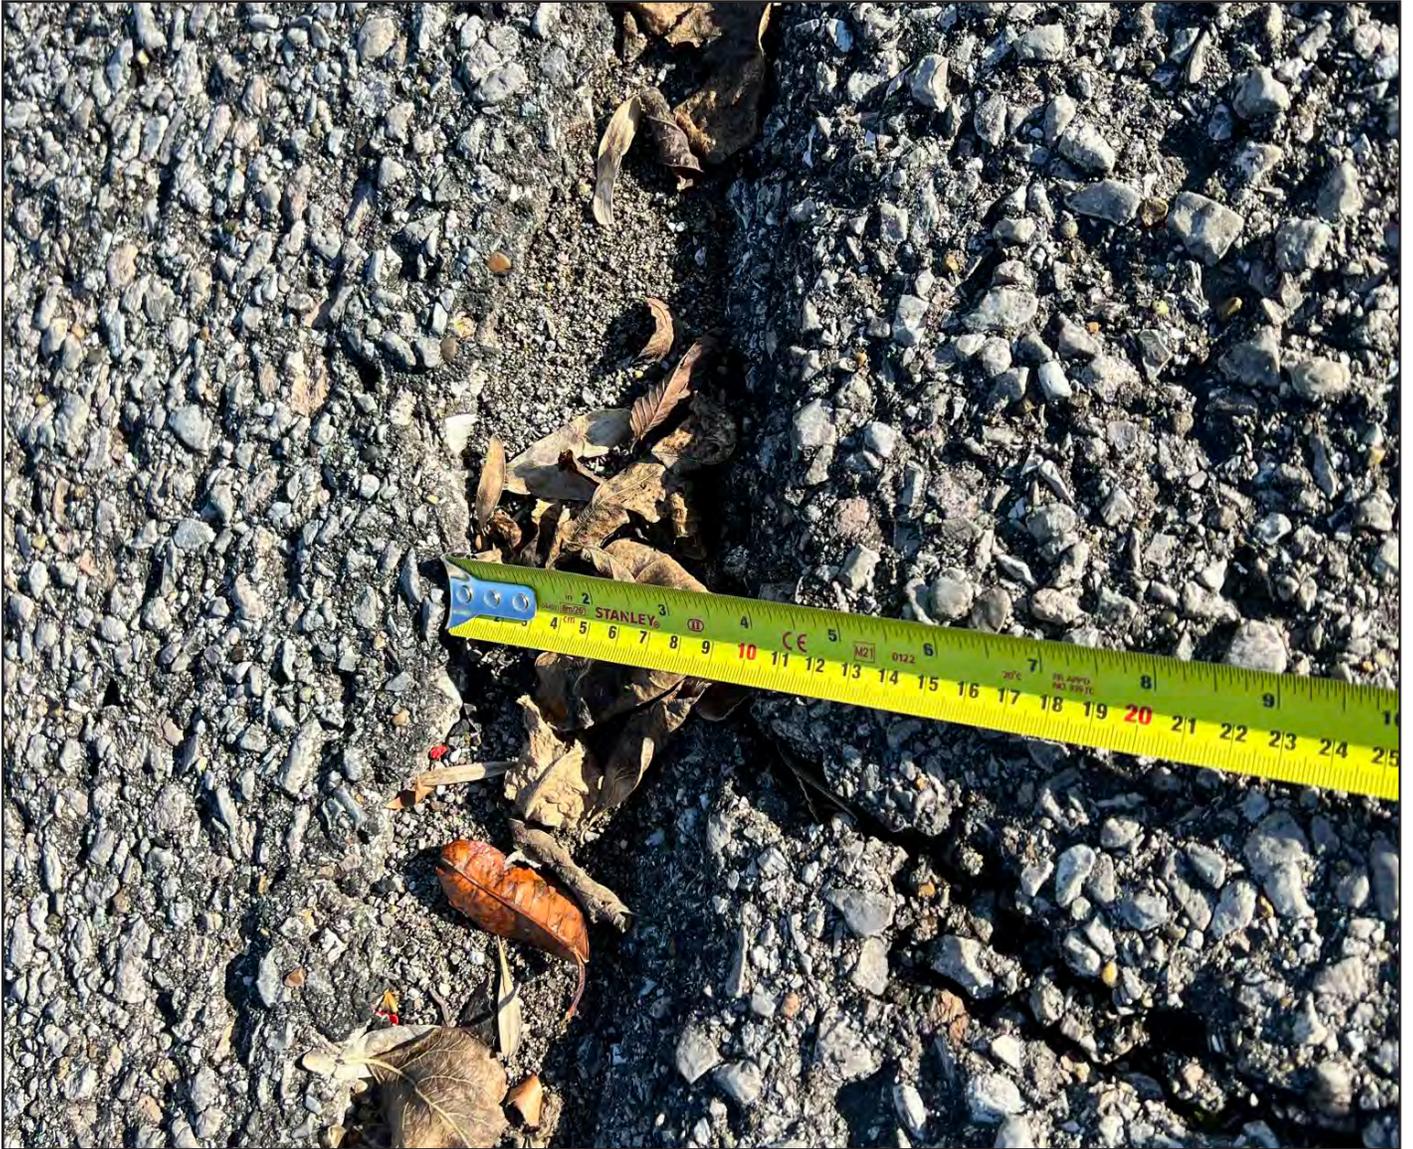
- Spalling at joints between paver runs leading to longitudinal cracks forming.
- General damage to the asphalt surface caused by vehicles losing control
- Patch repairs to the asphalt surface
- Aggregate loss from the asphalt matrix
- Bumps / undulations in the asphalt due to its ages

Cracking and deterioration of the asphalt surface increase water ingress into the surface as subsequently create the conditions for pavement deterioration to speed up. Hence maintenance of asphalt is a key factor in its lifespan. On site there was no obvious evidence of crack repairs or other maintenance recently.

Cracking at joints which has subsequently spalled at the edges leading to a 4 inch gap in the asphalt.

The large cracking in the track should be filled with an appropriate asphalt crack repair product and methodology to stop further water ingress into the circuit and spalling of aggregate in the near term, until a resurfacing project can be carried out. This would only be a short term solution and attention should be paid to the product selected for its strength and grip properties.

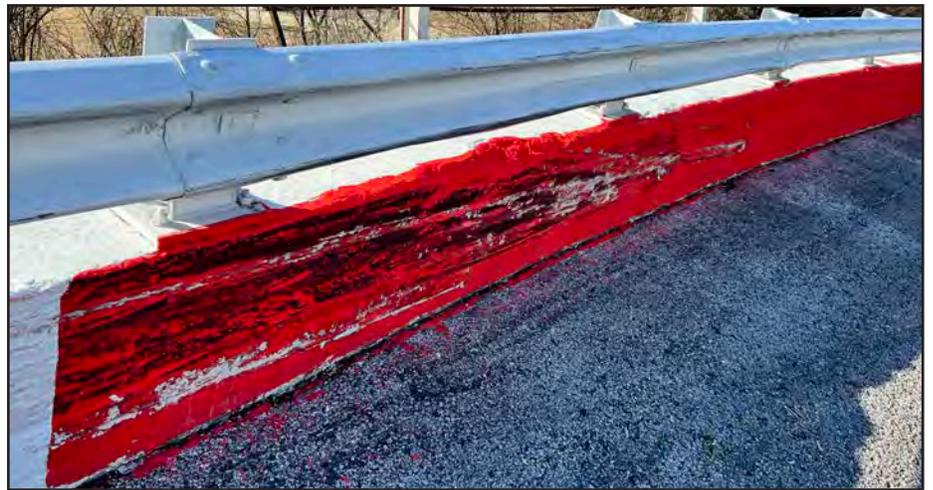
Generally the concrete wall is in a tolerable condition but is beginning to show signs of damage in areas that have been subjected to repeated impacts. It is outside of the scope of this assessment to provide structural analysis on the wall but obvious visual signs of cracking/failure were not seen (note the thick layer of paint).

Typical outside barrier arrangement.

Notably, the concrete section of the wall is not deemed high enough when compared to other international and national motorsports venues and thus has been previously extended through the addition of a single row of Armco rigidly bolted to the top of concrete around the curves. This Armco has not been added on the straights or on the inner walls leaving the concrete at its original dimensions.

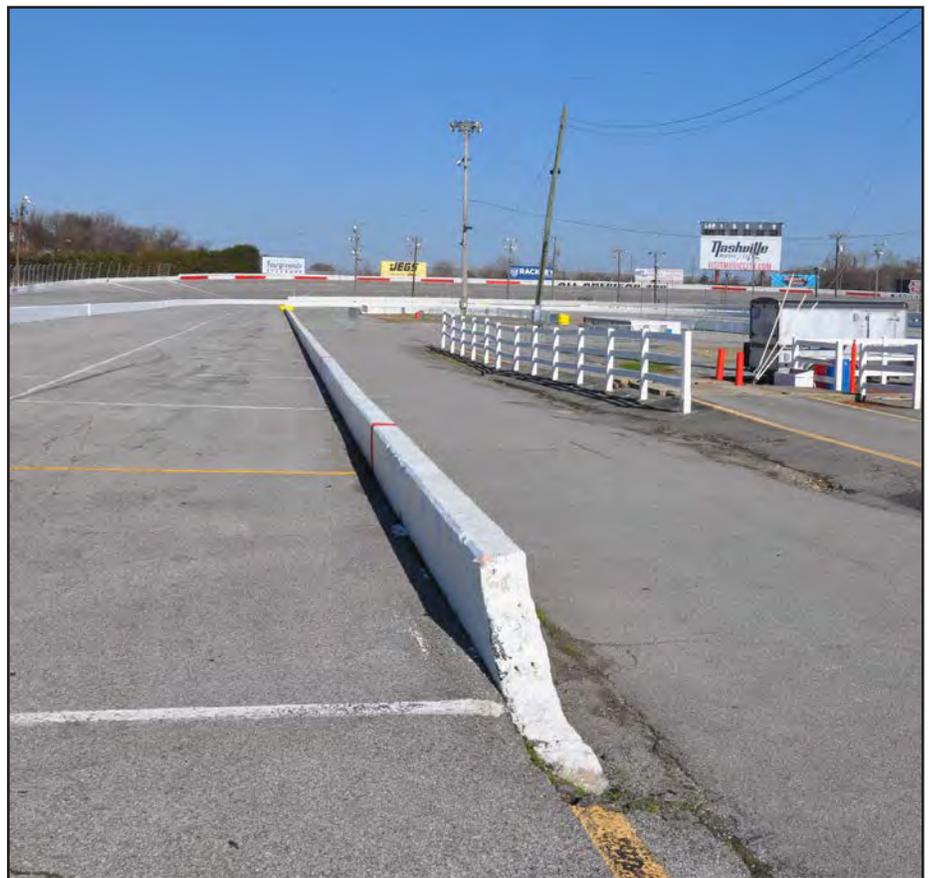
On drivers left of pit road is another low concrete wall, similar to most oval racing tracks, with the addition of occasional gaps to facilitate use of the smaller infield oval.

The available length of wall may be short if the desire to run larger events develops in the future. There is currently grass area available if this was to be extended in future.

Pit road protection

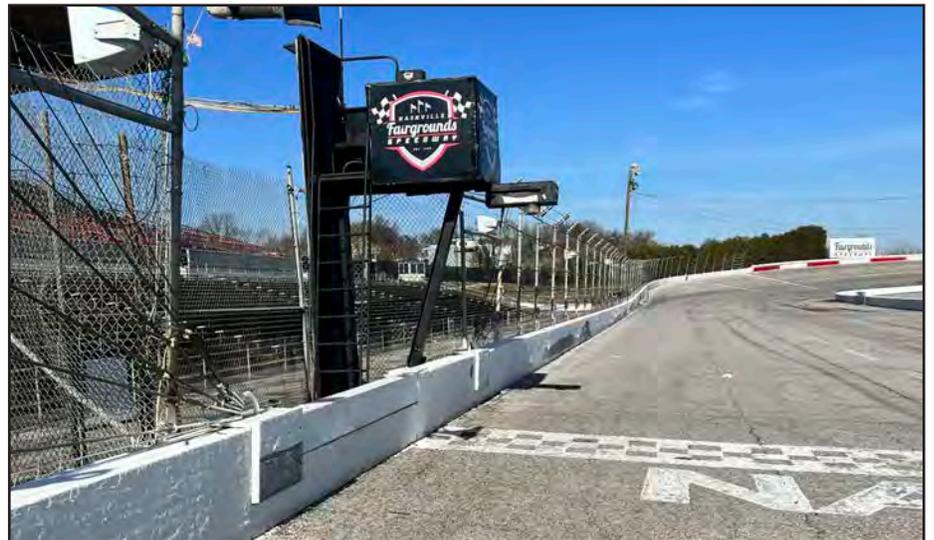
The catch fence at Nashville Fairgrounds Speedway is a tensioned product made of a wire mesh and tensioned steel cables run between posts. The fence is vertical with a short section at the top cranked 45 degrees towards the track. This is a different configuration to many NASCAR ovals which are now using taller catch fencing with the top rounded towards the track to provide more containment.

The fence is tensioned using a metal U shaped anchor bolted through the wall. The anchor interrupts the flush concrete face of the wall and is not advised due to the protrusion into the racing area which could risk catching on a vehicle.

Tensioning points for catch fence and flag box

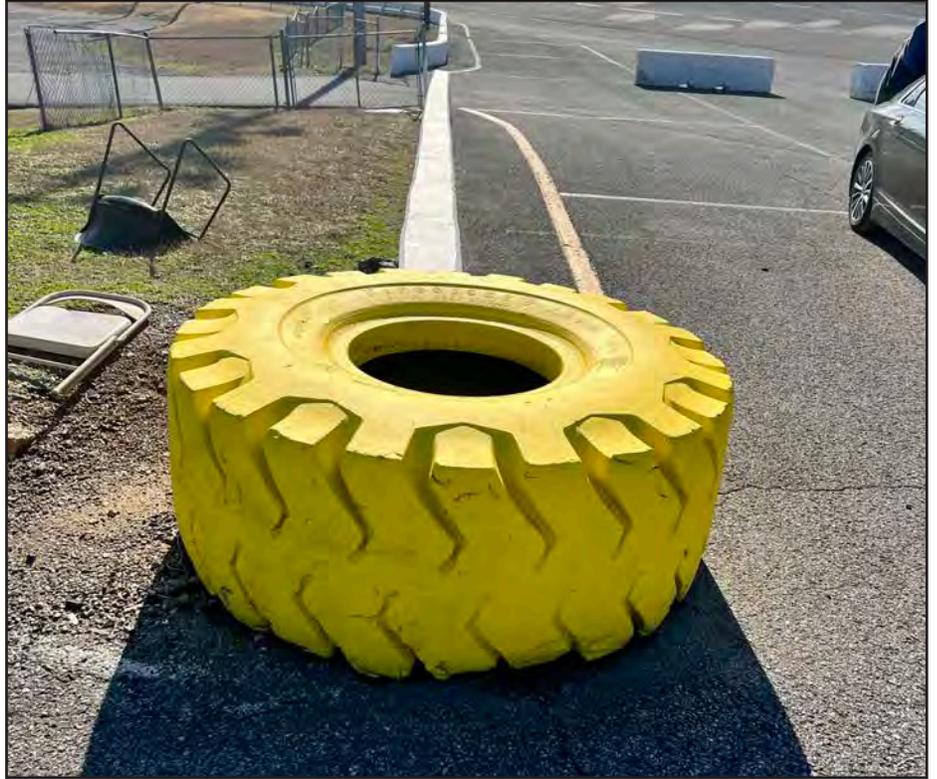
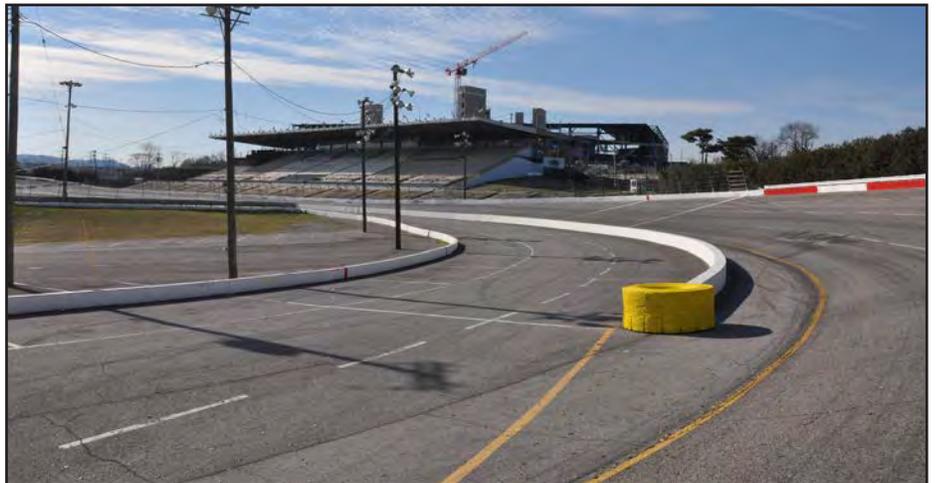
The entry to pit road has the end of the concrete wall protected by a large tyre as a vehicle attenuator. This set up is repeated on other exposed barrier ends. There is a risk that the tyre could move during an impact, or fail to provide sufficient damping during an impact.

Heavy machinery tyre as attenuator

The use of heavy vehicle tyres as attenuators on the end of exposed concrete walls is not desirable. An upgraded attenuator is recommended to be installed at all exposed concrete wall ends to assist in a scenario where it is hit by a vehicle.

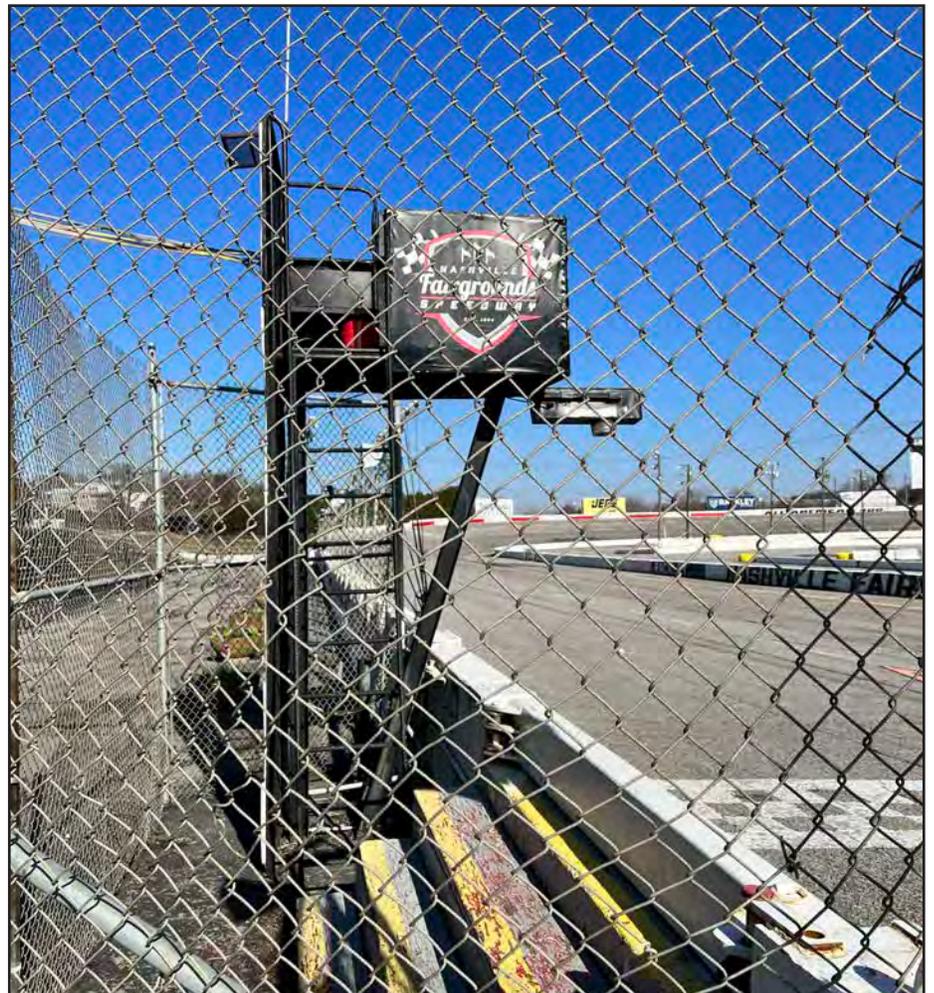
The existing flag box is a simple platform overhanging the track

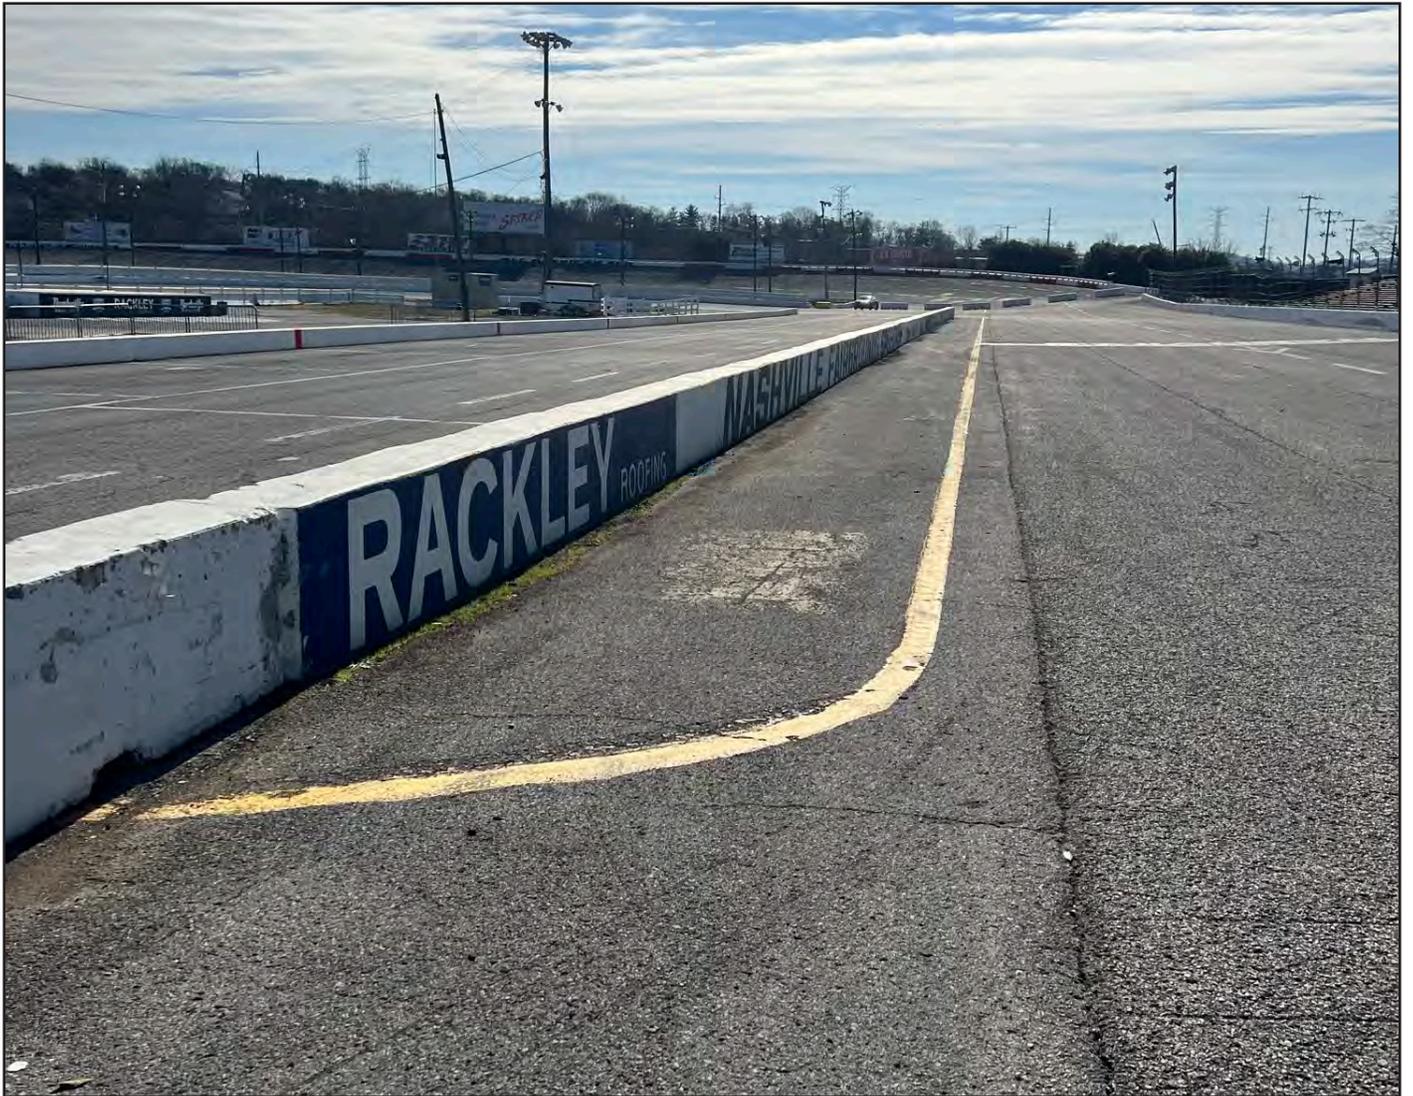
At pit road the drainage was observed to be obstructed by the wall which may cause a build up of water against the wall and / or slower drainage of the pit road working area. Grass & moss can be seen growing in front of the wall on the asphalt surface indicating the water ponding here after rainfall.

Moss and grass can be seen growing in front of the wall, indicating water ponding here after rainfall

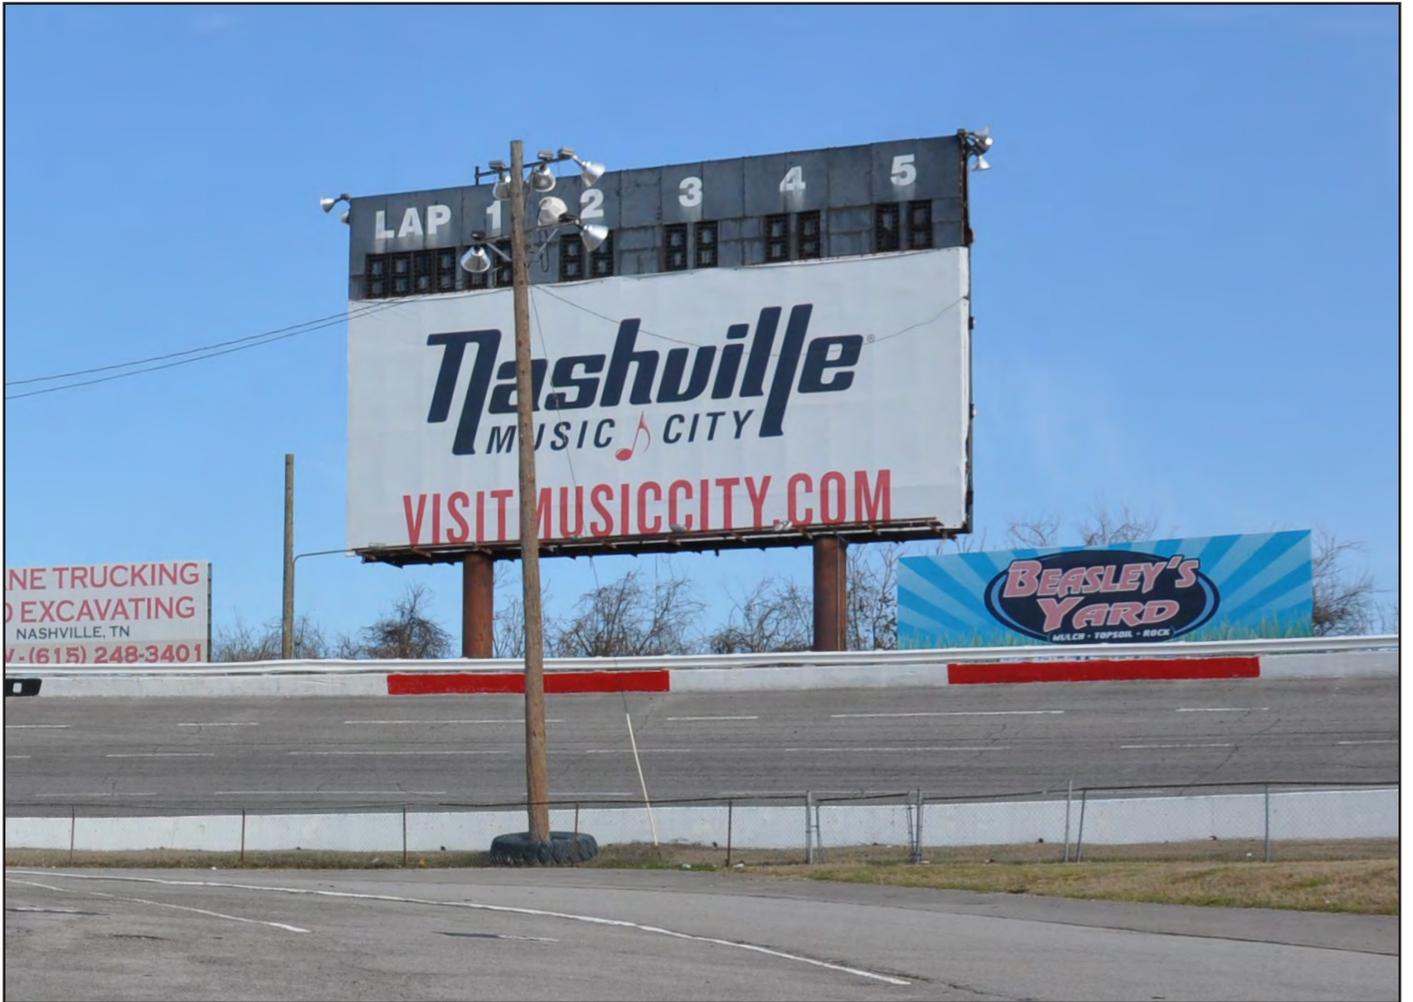
The scoreboard is looking dated and is not as effective as it could be

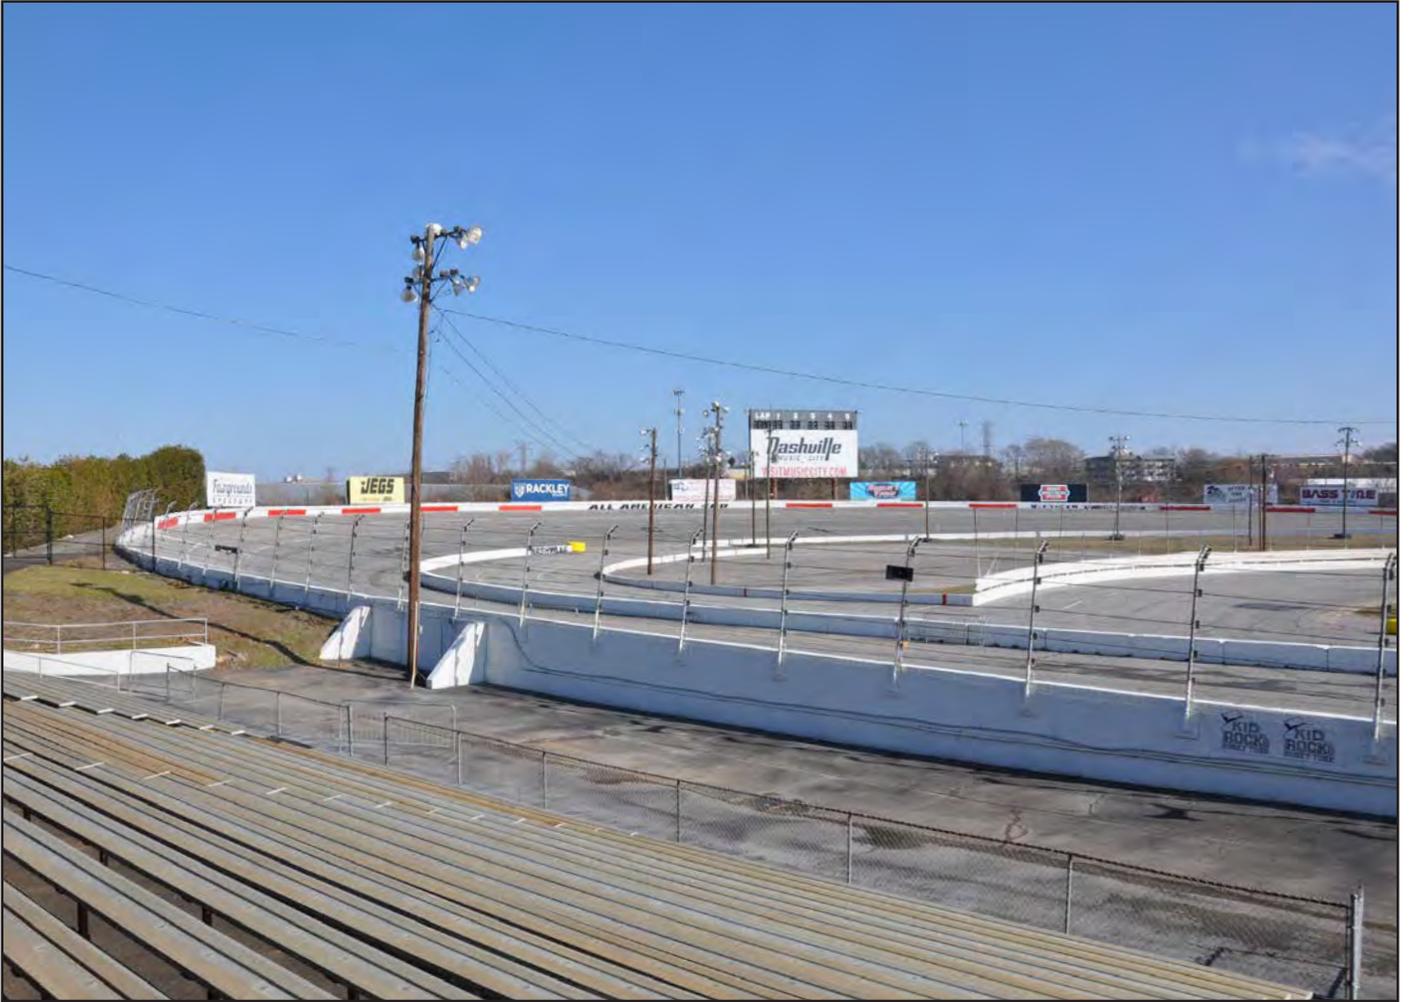
There is currently no noise mitigation around the perimeter of the speedway

Previously consultants have presented proposals to provide a 20ft noise barrier around the circuit. The purpose of such a barrier is to provide improvements to the local community such that the noise impact from the speedway is kept to a minimum. Motorsports venues are increasingly requiring advanced noise mitigation plans when situated near to built up areas. Whilst the noise barrier not affecting racers or spectators at the venue it is recommended as a measure which will help the speedway within the community, particularly as further development happens in the area.

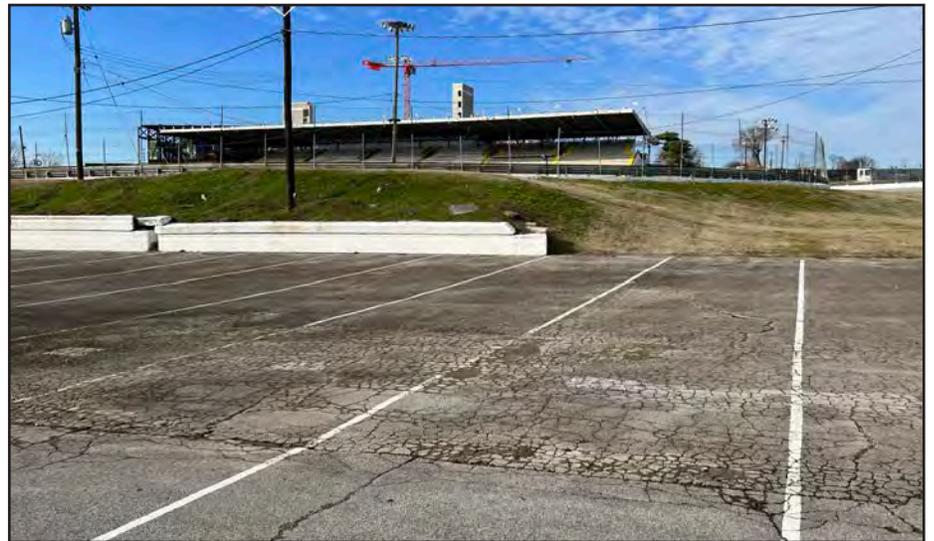
The surface on the infield is functional but beginning to deteriorate. The surface ranges from grass and dirt to paved asphalt. Particularly in the areas used by trucks the asphalt is now cracking in an alligator pattern. There are few drainage features and generally water is allowed to run off the surface into the adjacent grass.

Based on the alligator cracking the pavement may be failing in the lower layers of pavement.

Asphalt cracking on infield

Given the failing surface within the paddock reconstruction of these areas is likely to be needed soon unless the intention is to let the surface deteriorate into an unbound type surface throughout. There may be an opportunity to utilise less intensive repair methods in some areas

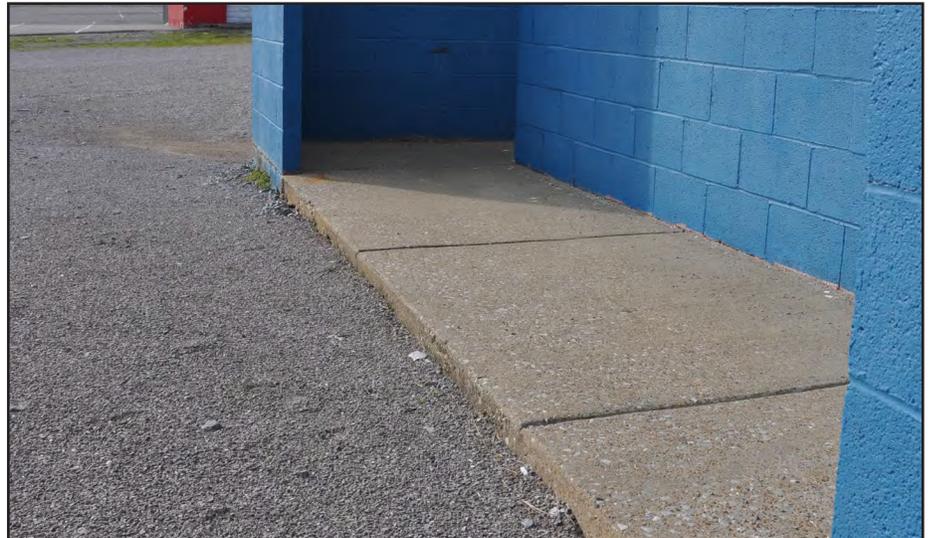
There are some potential issues of level access into the restrooms with a small step. Additionally, the ground around the restrooms has varying gradients and some deteriorated paving.

Small step up to infield restrooms

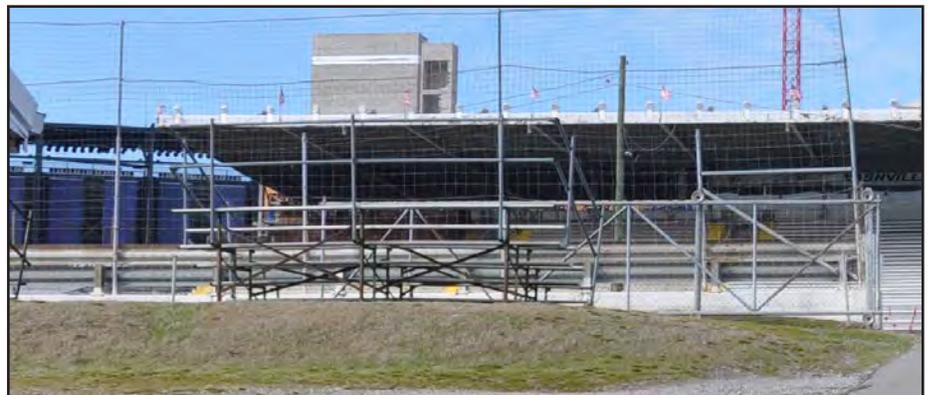
The mini bleachers that face the smaller oval track are well used by teams on a race day. They appear functional in design and given their age are unlikely to be designed to modern standards.

Mini bleachers on the infield facing the smaller oval

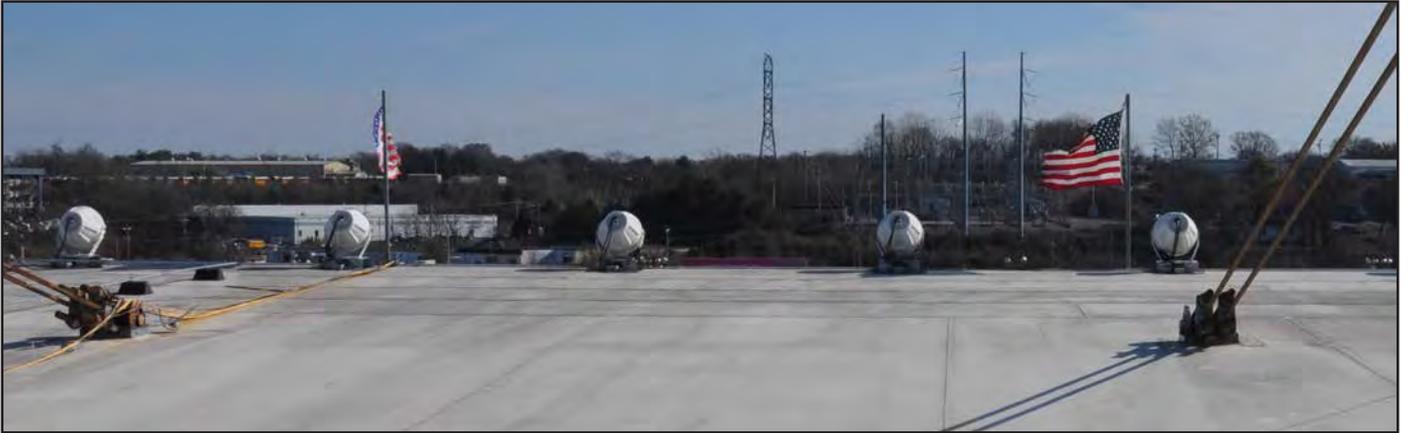
The roof of the grandstand appears to be in reasonable condition, and we were told had had a recent structural assessment. There are numerous cosmetic problems, such as paint flaking off in several places and ripped flags which bring down the overall appearance of the venue. The roof appears to be in good condition, however there doesn't appear to be any safety system for use while working on top of it.

There is no visible mansafe or safety line system for working at height on the roof

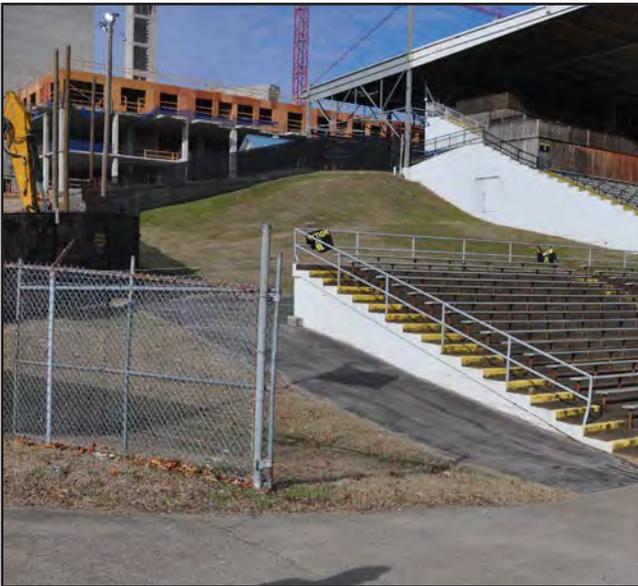
The grandstands sit on a steeply sloping site

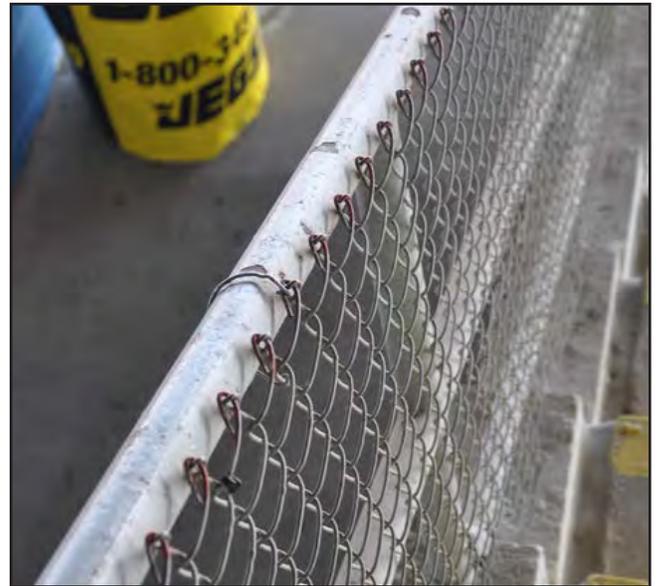
Access to the seating is covered in the following chapter. Concrete half steps have been formed to make the steep rise more manageable, but these half steps have broken in places. Some handrails are wobbly, and some have a wire mesh fixed to them which is exposed to the handrail which is a poor detail. Disabled access is limited with access being limited by the slopes and steps

Exposed wire fence next to handrail

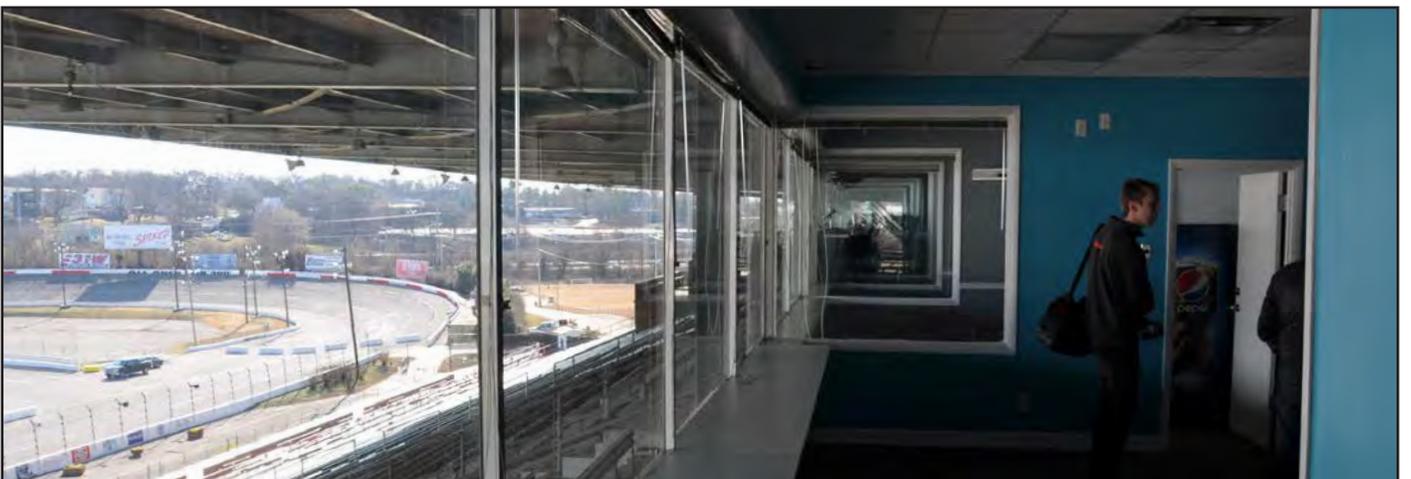
The race control and other offices at the top floor of the grandstand appeared functional, if a little dated.

Offices and race control appear in reasonable condition

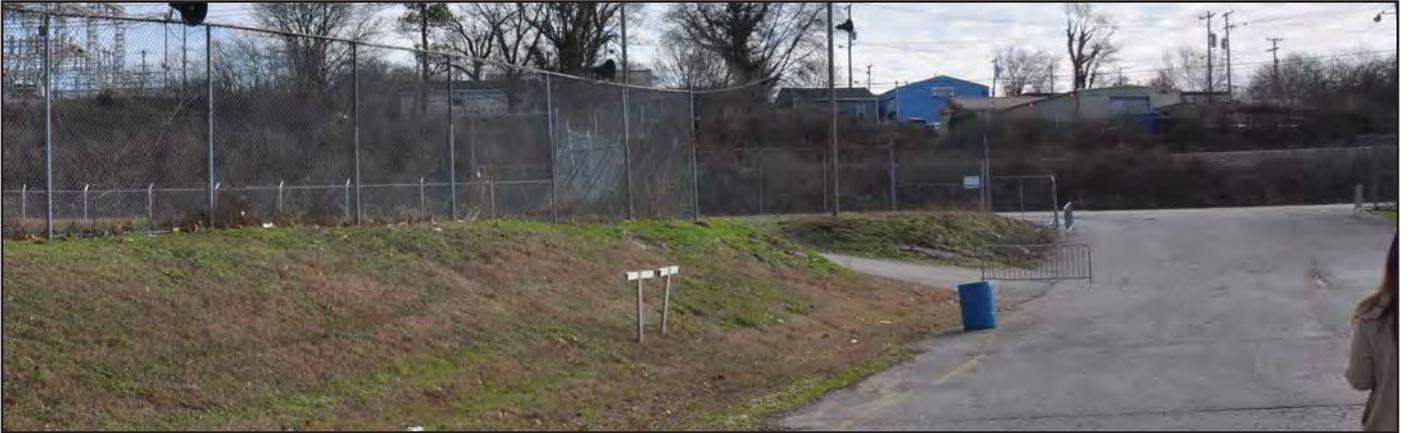
Steep access to the left to the camping area

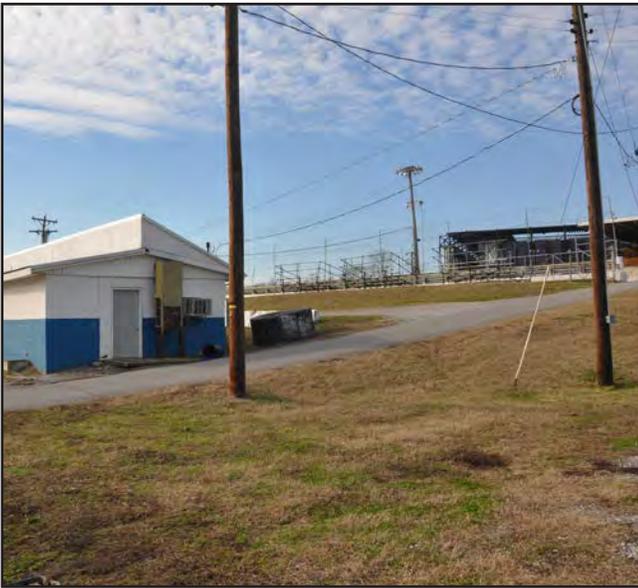
Steep slope leading to the mini bleachers on the infield

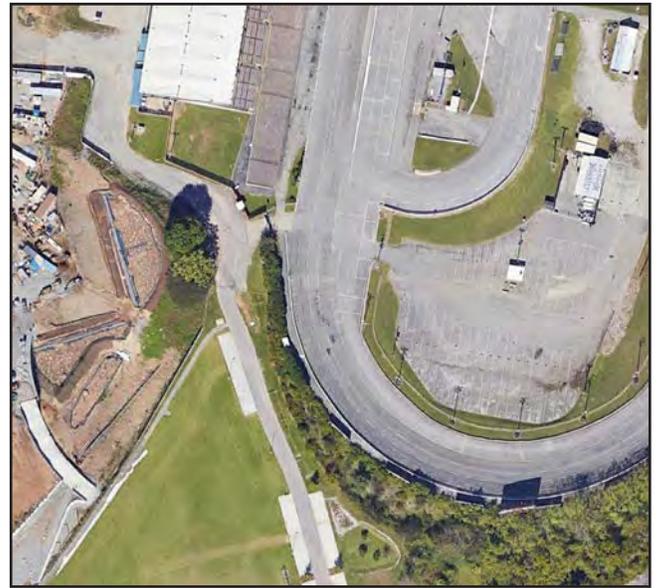
South West access is gently sloping with no direct footpath

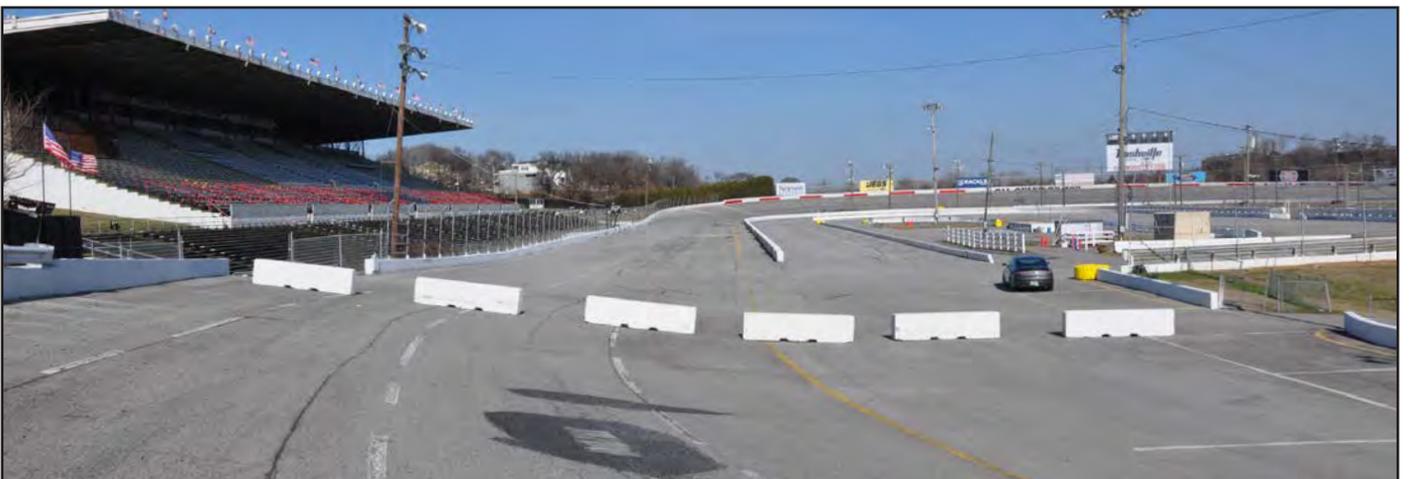
Pedestrian circulation between the grandstand area and the infield is limited, and could be a lot better. The current options for pedestrians crossing the speedway are to leave the venue entirely and circulate around the South West road network, or to wait until track activity has ceased and circulate towards the South West gate up the steep banking of the speedway itself. Either of these routes is not ideal for people with mobility issues, meaning that any of the concessions or facilities available at the grandstands will be difficult for these users to access.

The pedestrian crossing over the speedway is quite steep on the outer edge

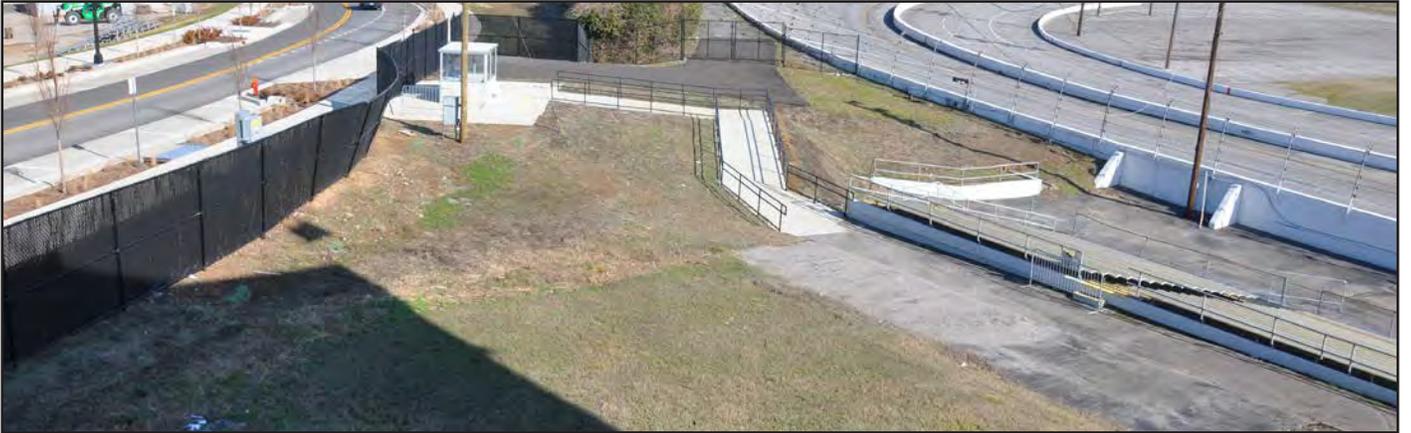
ADA Compliant ramp and viewing area, but does not connect to the rest of the venue

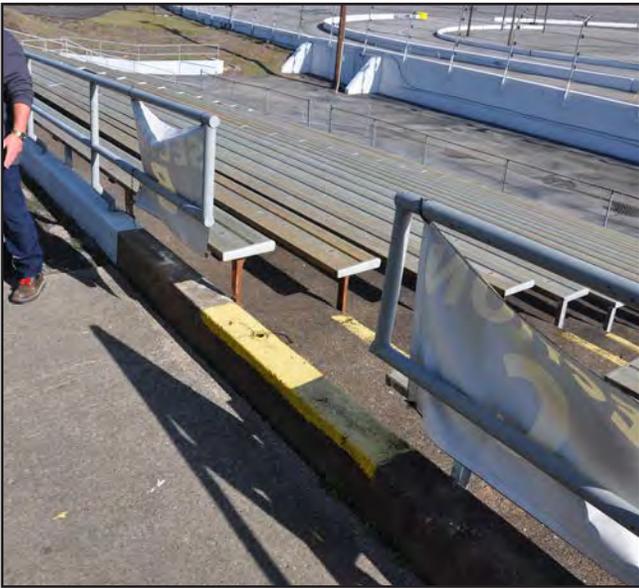
Upstand at the top of the bleacher steps

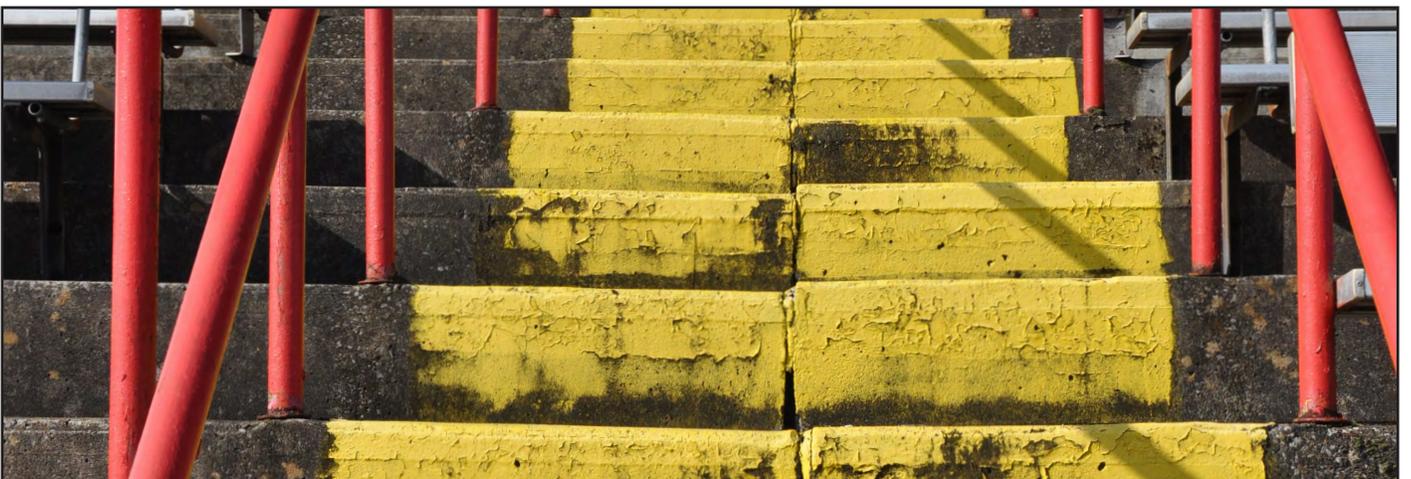
The steps up the grandstands are unevenly spaced in many places and are positioned right on the movement join of the grandstand. Due to movement in the structure over the years, this has created an awkward level change along the centre of the treads which could be a trip hazard in the worst affected areas.

Steps are uneven due to movement joint in grandstand

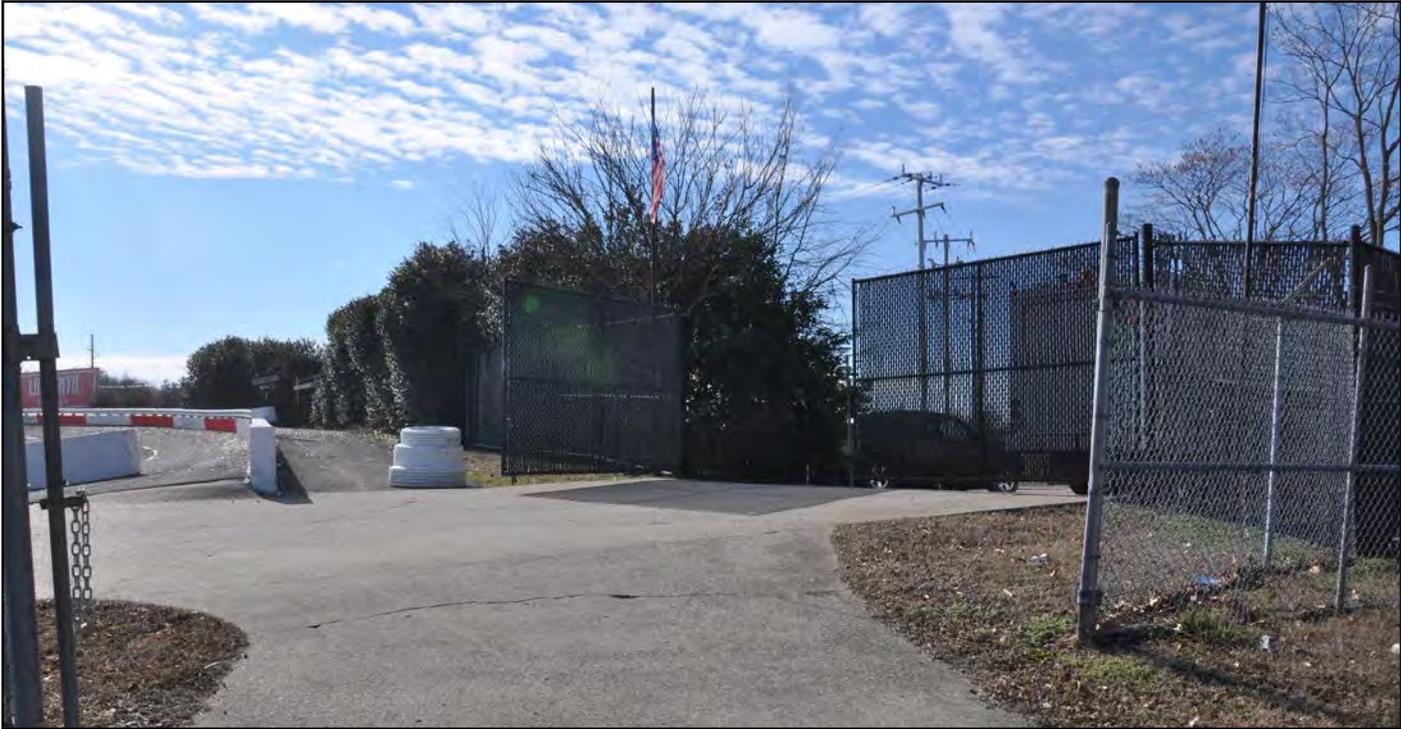
Current access for trucks to infield

Trucks are scraping along the Speedway asphalt as they navigate the steep access to the infield from the South West gate. We recommend to counter this, the surface either side of the speedway is levelled out to ease the transition of the trucks.

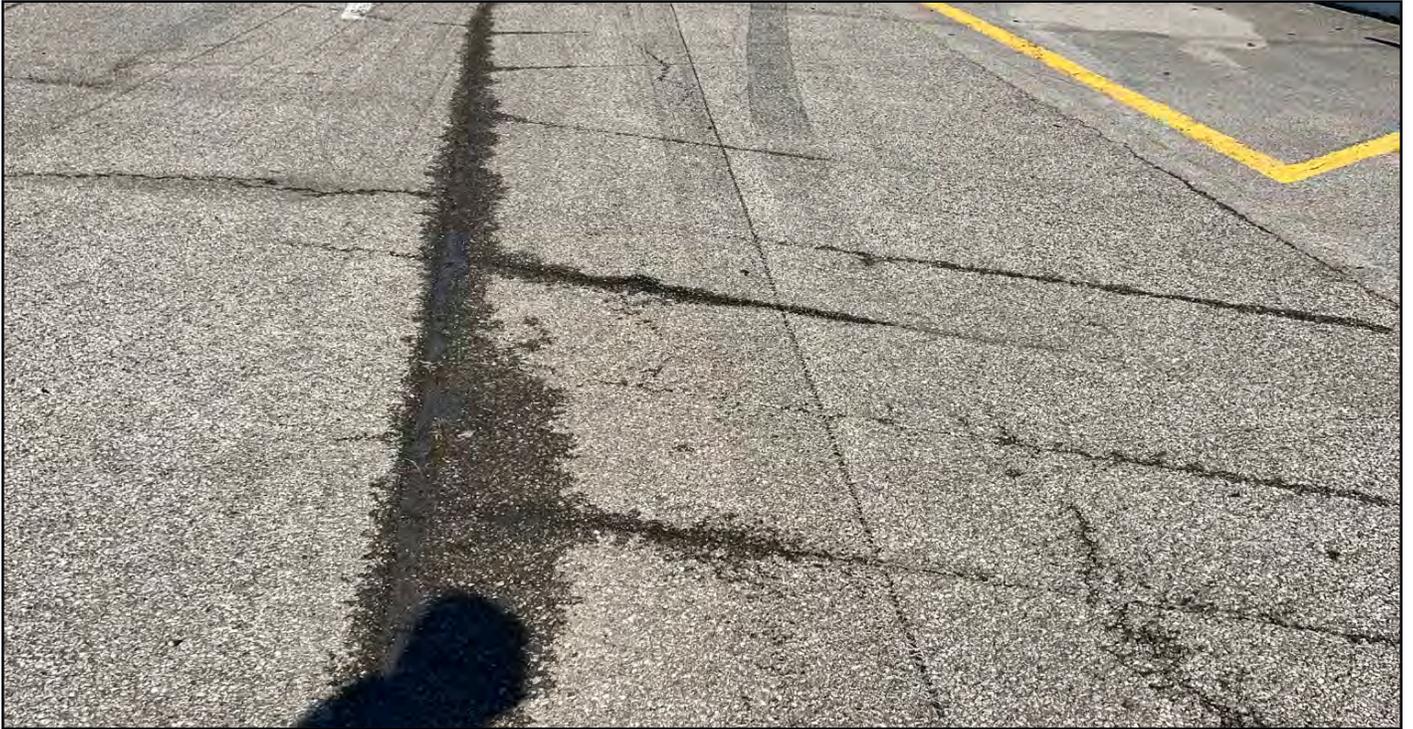
Existing drainage problems on track

The presence of water coming through the lower parts of the banking indicates water beneath the track / migrating through the asphalt. It is recommended that during resurfacing works the below track drainage is upgraded. This will require further investigation to design but a granular drainage mat or filter drains may be appropriate to alleviate the problem.

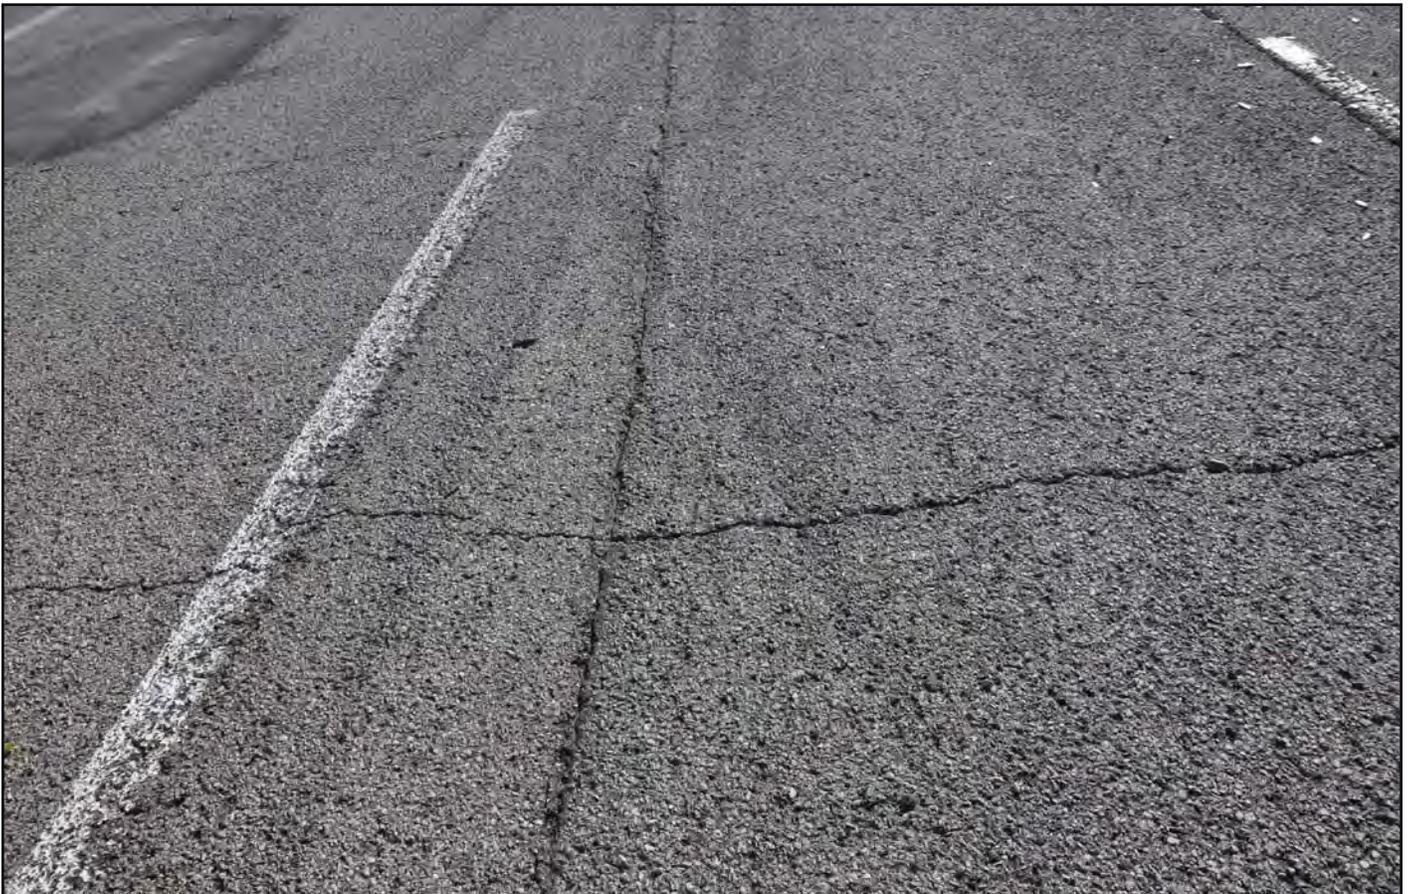
Visible cracking in asphalt
